DESTROYER ENGINEERED OPERATING CYCLE (DDEOC)

System Maintenance Analysis DDG-37 CLASS FIREMAIN AND AUXILIARY MACHINERY COOLING WATER SYSTEMS

SMA 37-201-521

REVIEW OF EXPERIENCE

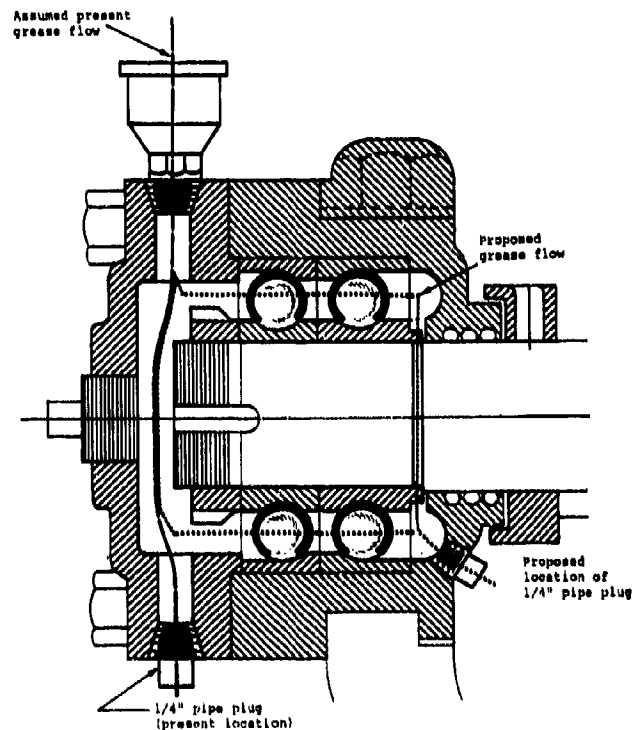
Figure 3-1. TYPICAL FIREPUMP BEARING AND HOUSING

The firepump is equipped with two externally grease-lubricated ball bearings, a thrust bearing consisting of a size 307 double ball bearing and a size 307 single ball bearing. Table 3-2 shows that the thrust bearing was replaced 225 times and the single bearing 219 times during the data period.

Comments of NSRDC personnel reported in Section 3.1.1.4 suggest that the bearings stocked in the Navy Supply System are perfectly adequate for their intended use. However, it was further stated that current bearing installation practices used in the Fleet are varied and are of marginal acceptability, resulting in the high rate of bearing replacement noted. The provision of a comprehensive centrifugal pump overhaul manual for individual ships, as recommended in Section 3.1.1.2 of this report, could reduce the number of bearing replacements.

During analysis of the firepumps, it was further noted that the procedure currently used to grease the ball bearings does not ensure that the old grease in the ball bearing is purged and replaced by new grease. This may have contributed to the high bearing replacement rate by not allowing an adequate flow of new grease. The existing drain plug on the bearing housings is directly below the grease cup or zerk fitting, and it is possible that the fresh grease will flow directly out of the drain hole. The lubrication procedure could be improved by moving the drain hole to the opposite side of the ball bearing, thus forcing new grease to flow through the bearing in such a way as to ensure that fresh grease is introduced to the contact points of the ball bearings and the old grease is flushed out. Figure 3-1 graphically describes the proposed change.

It is recommended that a ShipAlt be developed to implement this recommended firepump bearing housing change on both bearings of the installed firepumps of the DDG-37 Class.
